# Stormwater performance of permeable pavement systems

Derek Booth, Benjamin Brattebo, and Jennifer Friebl

**The Water Center**

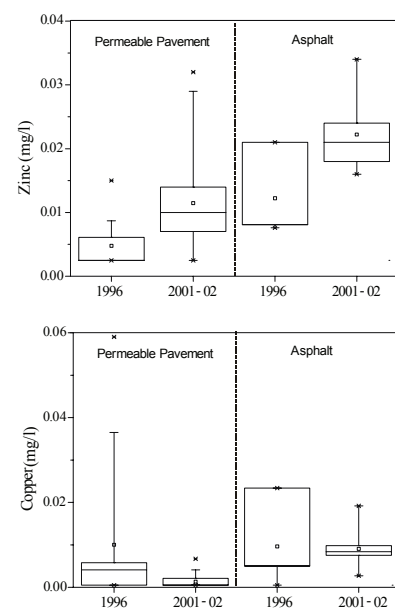
A comparison of zinc and copper concentrations in samples collected in 1996 and 2001-02. Concentrations for permeable pavement are averages of infiltrated samples from all four paving systems. For 1996, n = 12 from the permeable pavements and n = 3 from the asphalt runoff. For 2001-02, n = 27 from permeable pavements and n = 9 from asphalt runoff. The large box represents the 25<sup>th</sup> percentile, median, and 75<sup>th</sup> percentile; the whiskers represent the 5<sup>th</sup> and 95<sup>th</sup> percentiles; the small box represents the mean.

The long-term degradation of water-quality performance may be a modest, but probably not problematic, phenomenon of permeable pavement systems. Zinc concentrations in both permeable pavement infiltrate and asphalt runoff exhibited significant increases during the six-year study period. Yet two of the systems, Grasspave2<sup>®</sup> and UNI Eco-Stone<sup>®</sup>, showed simultaneous decreases in copper concentrations. Lead, present in a third of the 1996 samples, was not detected during the current survey. Conductivity and hardness remained relatively constant between the two studies.
